UNITED STATES ENVIRONMENTAL PROTECTION AGENCY
REGION 2
290 BROADWAY
NEW YORK, NY 10007-1866

Re: Phillips 66 Co., Bayway Refinery, Linden NJ
EPA/NJDEP NJPDES Permit Compliance Evaluation Inspection June 12, 13, and 20, 2019
NJPDES Permit No. NJ0001511 (NJPID No. 46318), NJ0026671 (NJPID No. 46322)

Enclosure – Inspection Report from June 2019 CEI

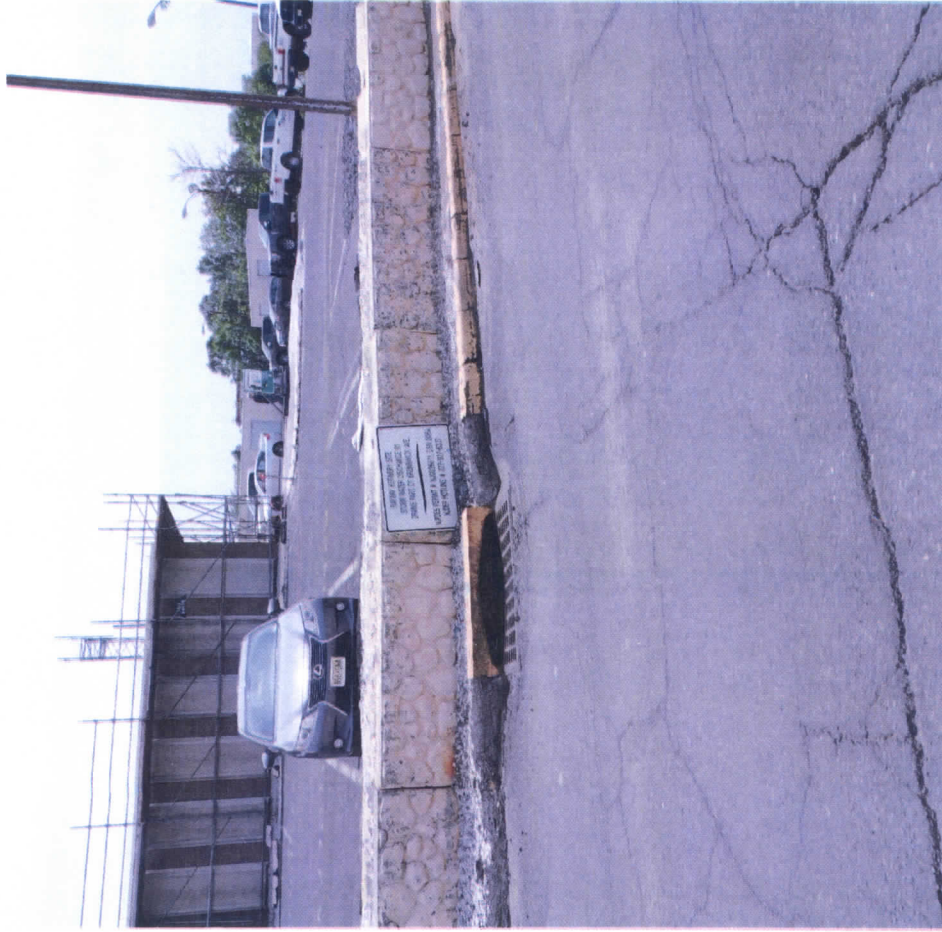
DSCN6710 – Stormwater Permit Outfall 006 – sediment accumulated on side of road. No Discharge – dry weather

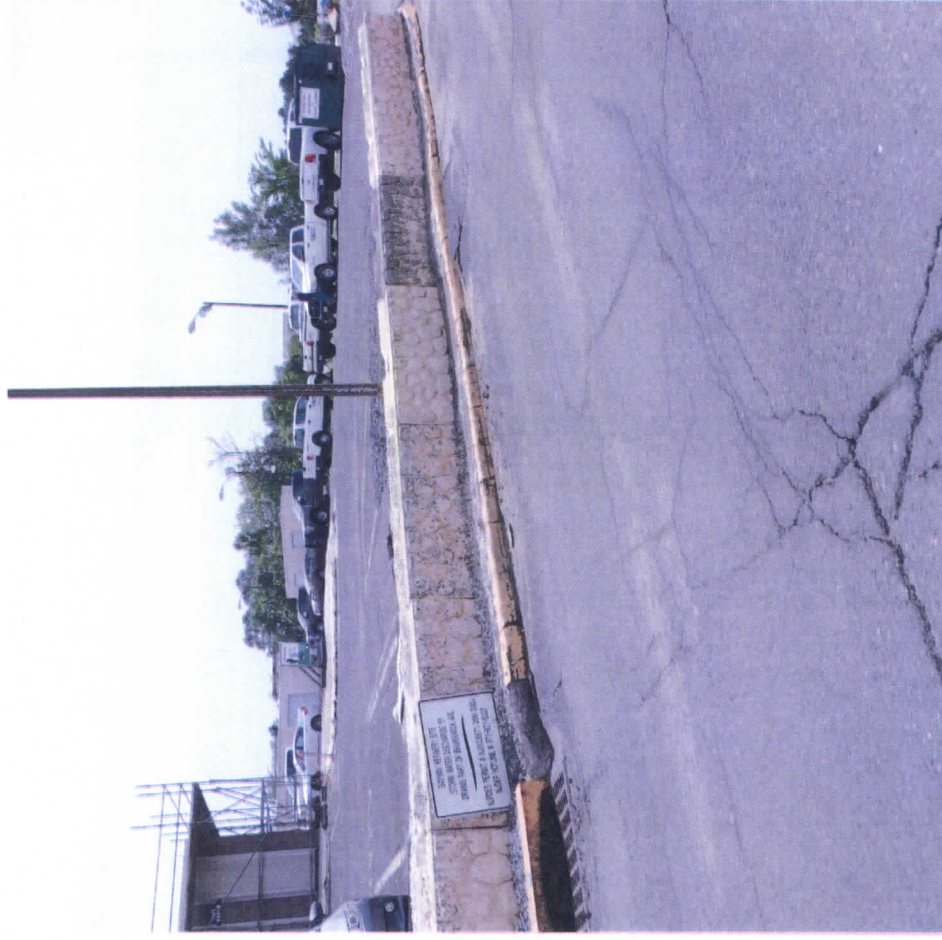
DSCN6711 – Stormwater Permit Outfall 006 – sediment accumulated on side of road. No Discharge – dry weather

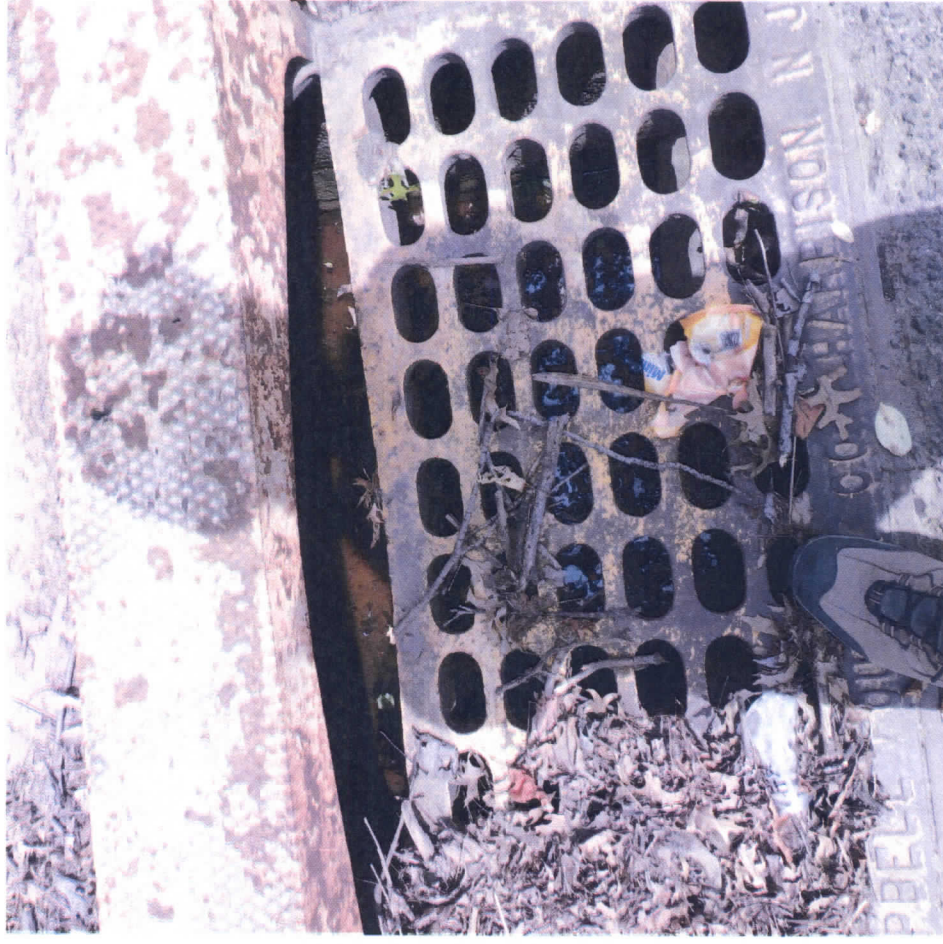
DSCN6713 – Material on catch basin along New Brunswick Ave tributary to Outfall 011

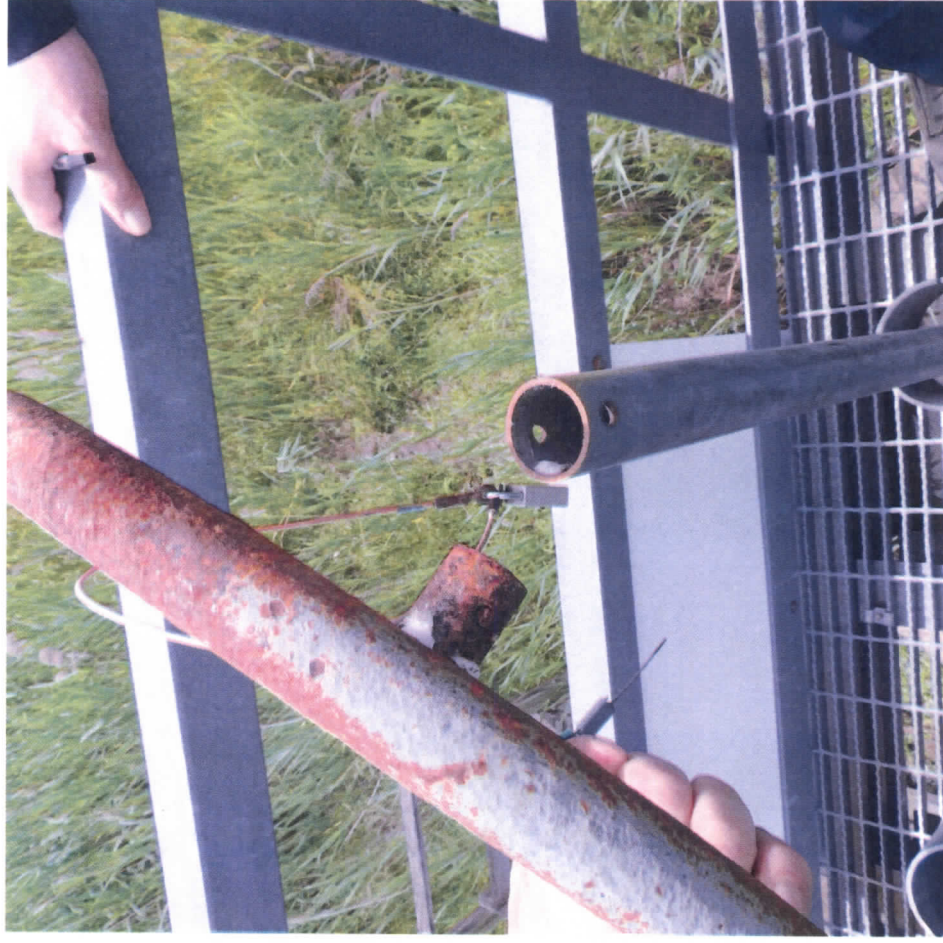
8. For Outfalls 017 and 009 the EPA and NJDEP representatives inquired about whether there the refinery had a program of valve maintenance (017 had a broken valve head).

DSCN6717 - One of the 2 Valve Heads at Outfall 017 was broken

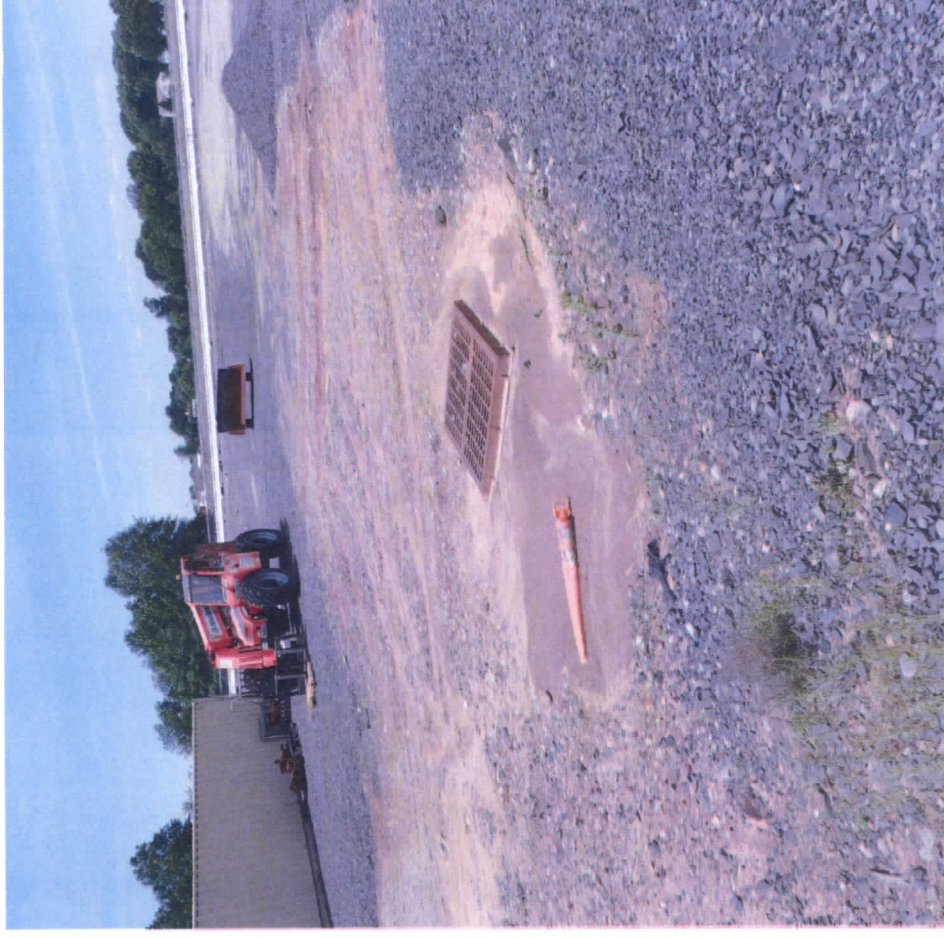
DSCN6719 – unstabilized soils around catch basin at the rail car unloading area

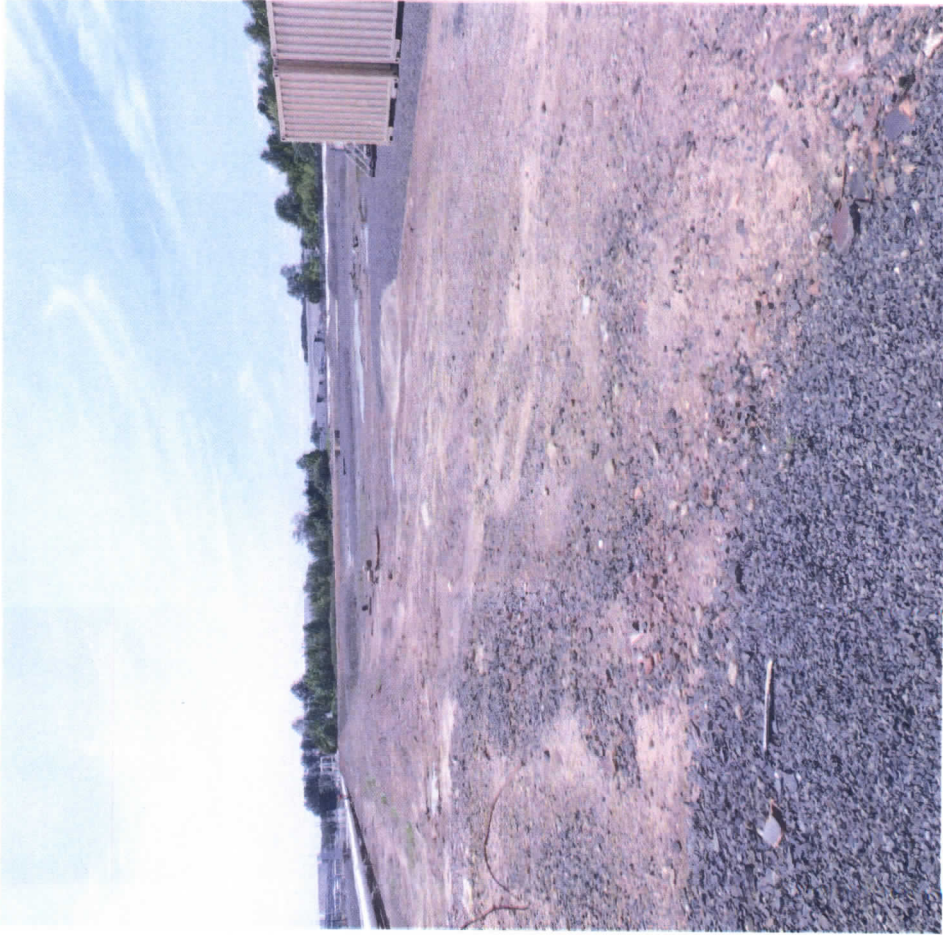
DSCN6720 – unstabilized soils in the rail car unloading area

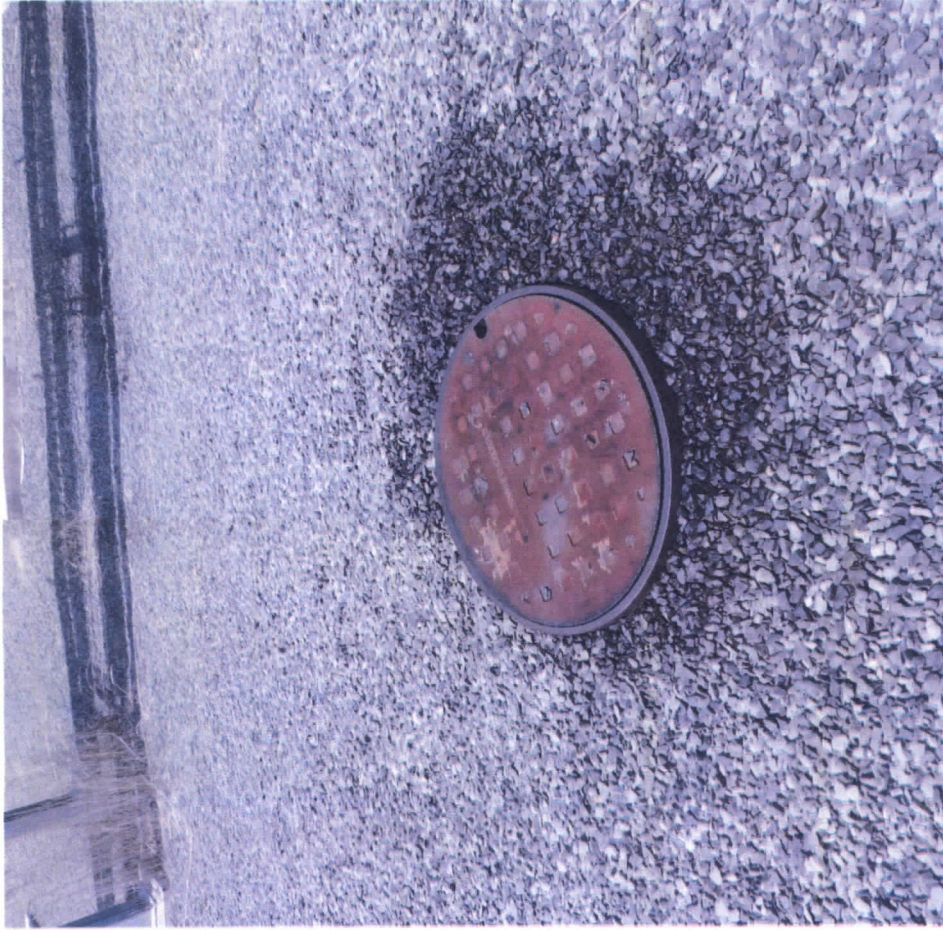
DSCN6722 – manhole that has had overflows that is on the way to the separator for the rail car unloading

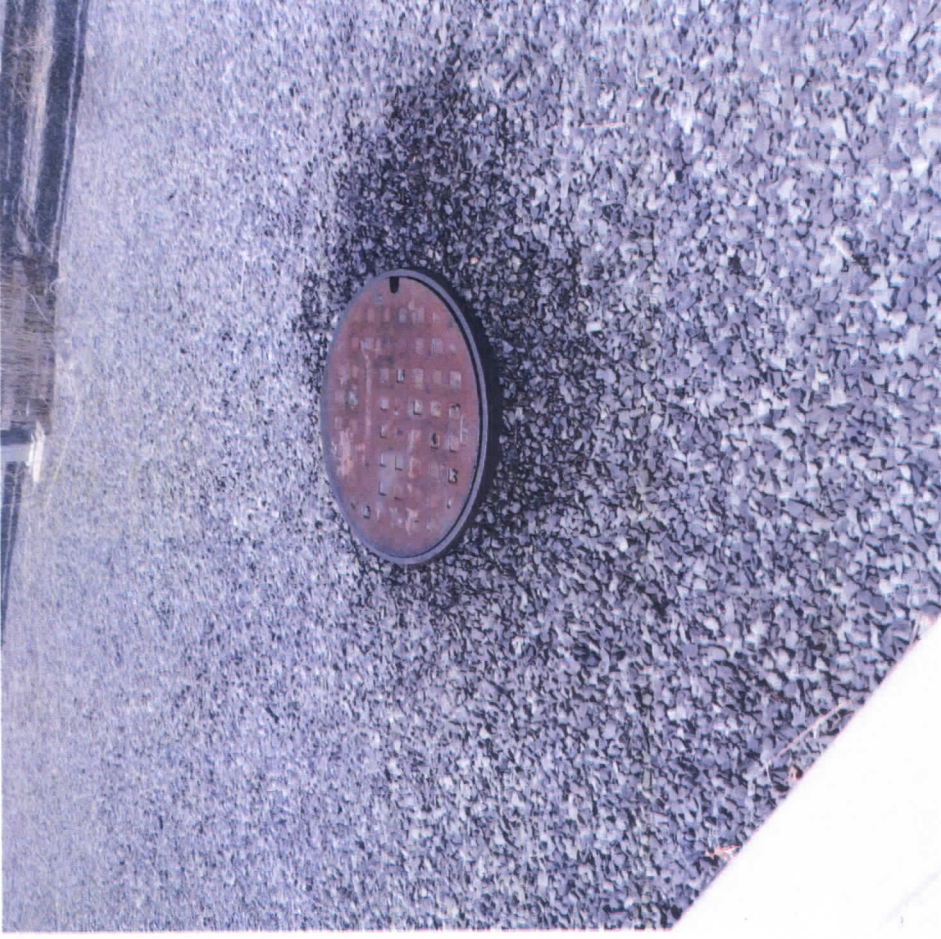
DSCN6723 - manhole that has had overflows that is on the way to the separator for the rail car unloading

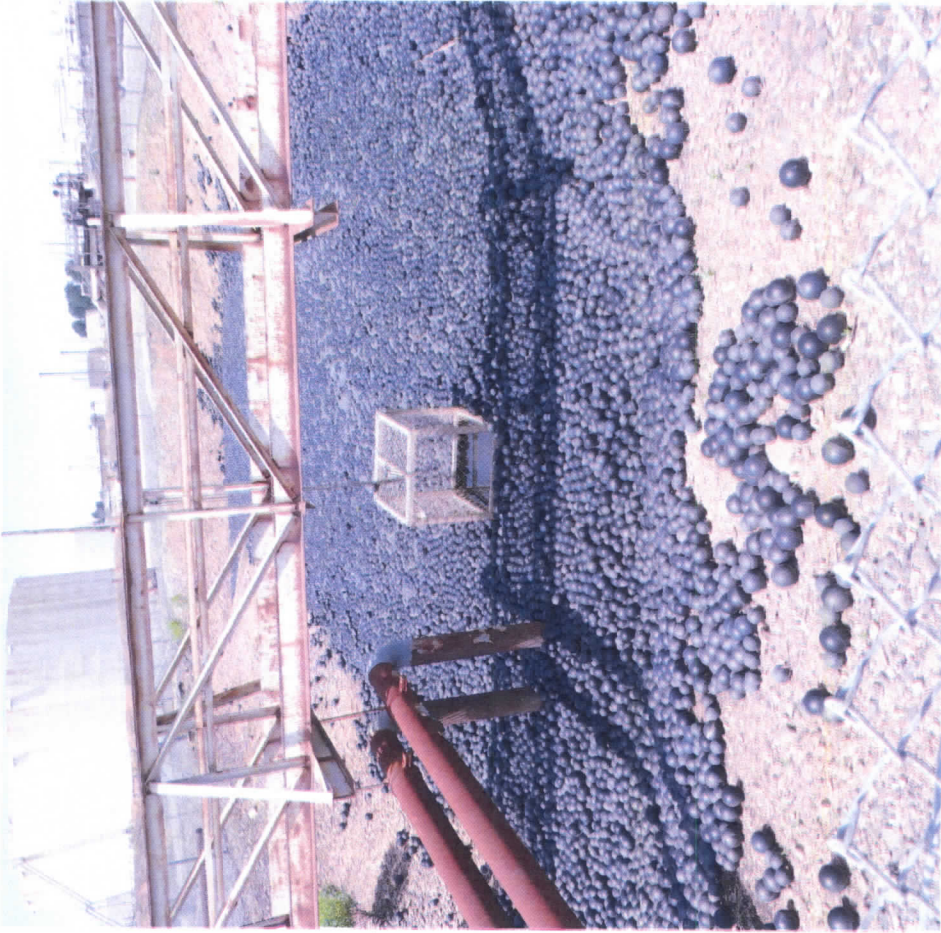
DSCN6726 – 018 Separator, downturned elbows

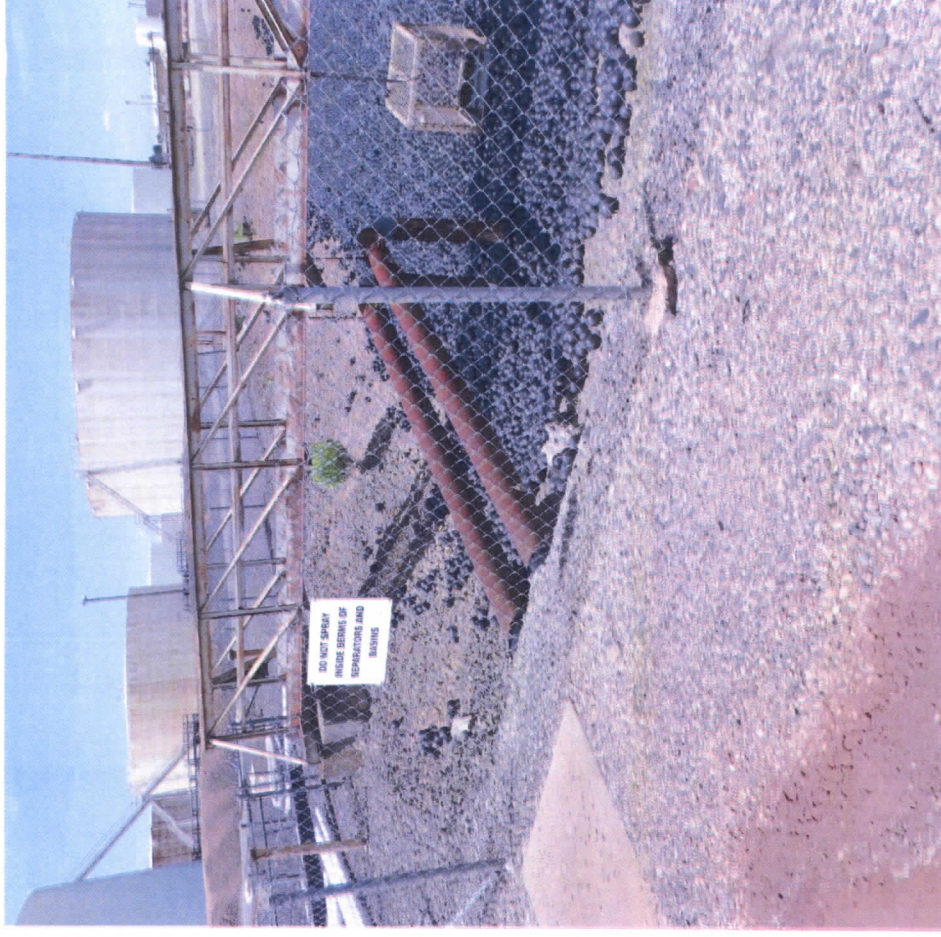
DSCN6727 - 018 Separator, downturned elbows

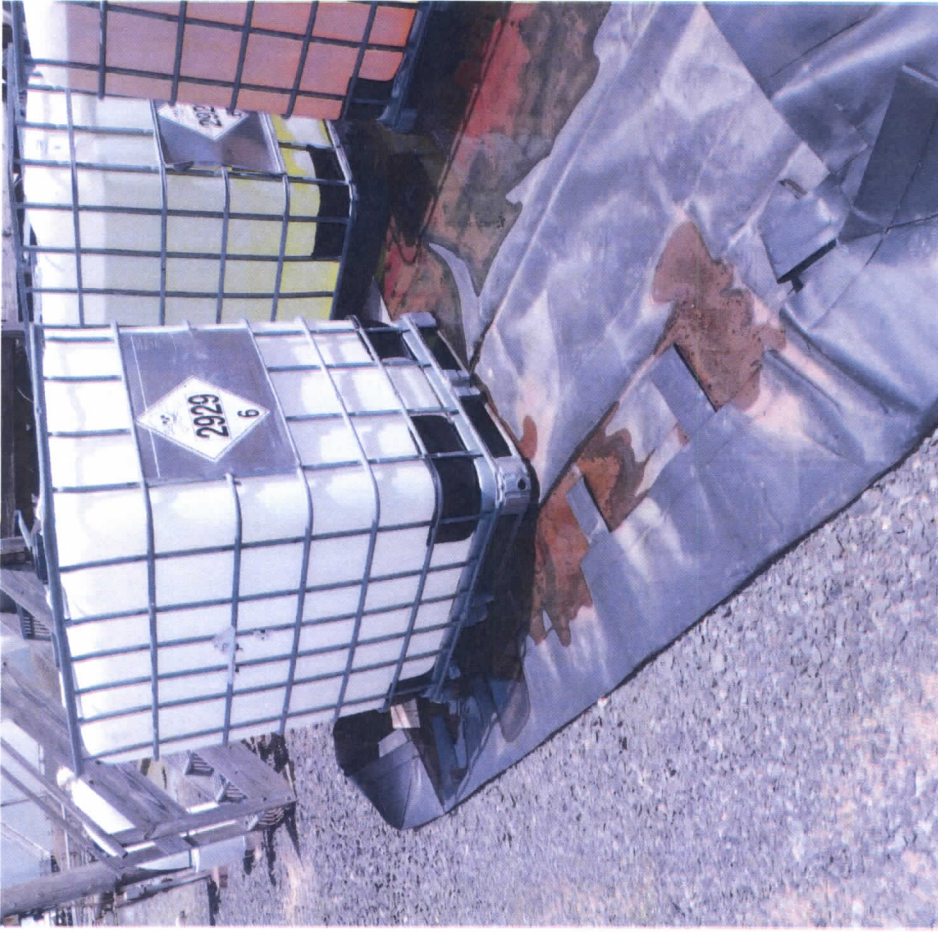
DSCN6730 – Additive storage totes – temporary secondary containment had collapsed

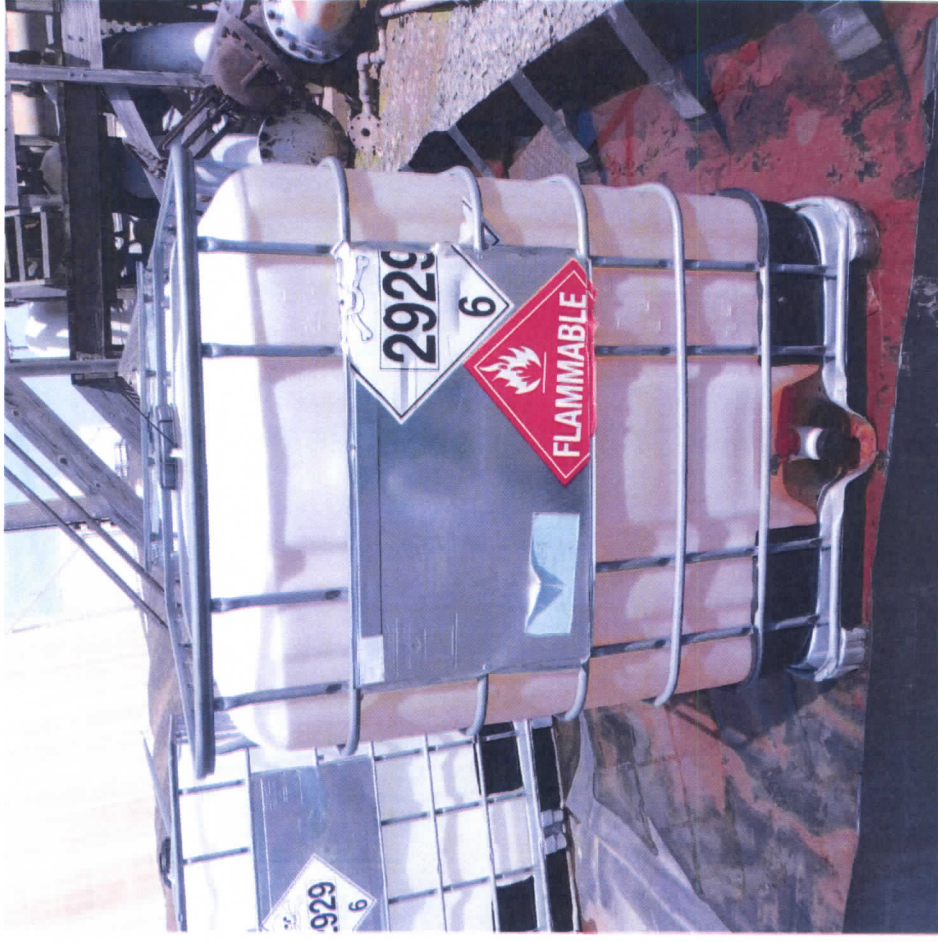
DSCN6731 - Additive storage totes – temporary secondary containment had collapsed

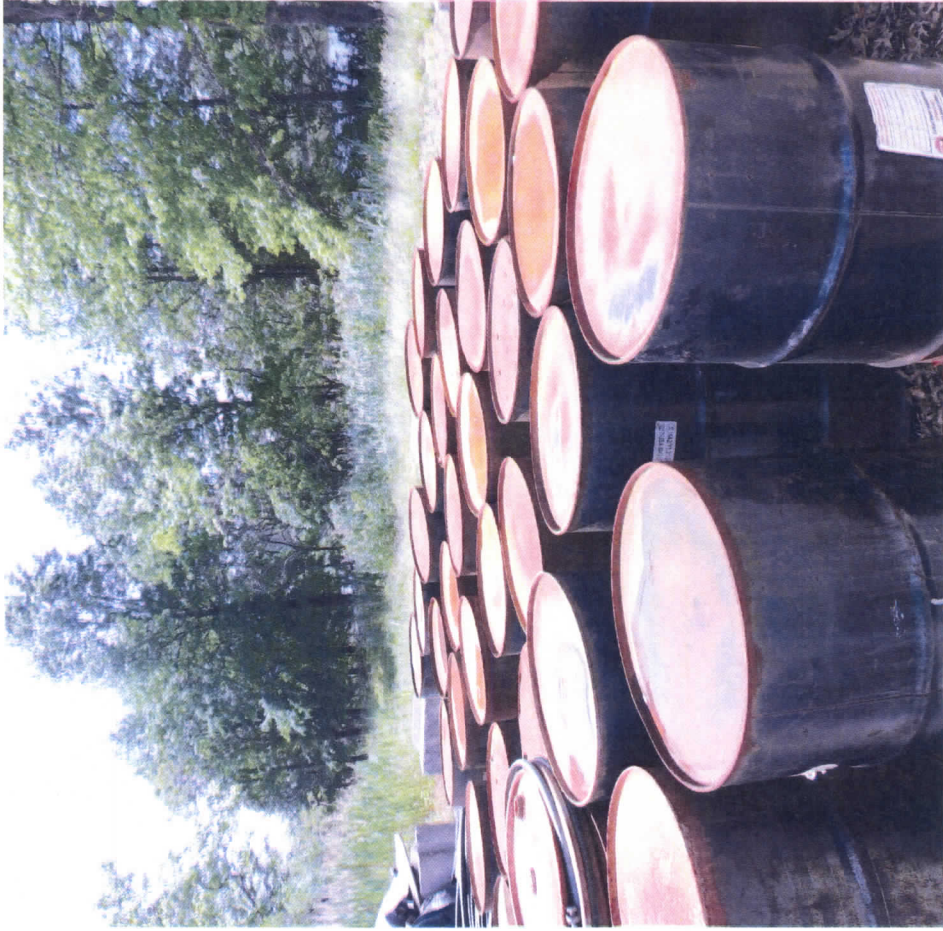
DSCN6736 – drum storage in Exxon storage area

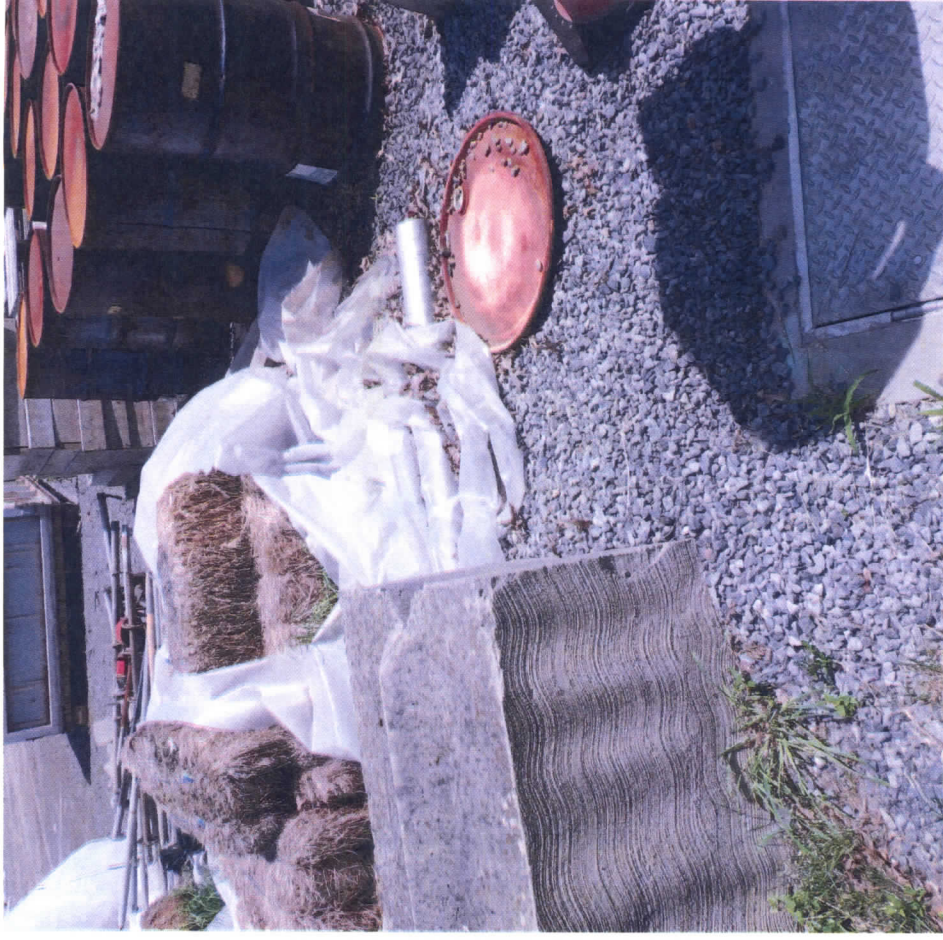
DSCN6737 – drum storage, hay bales in Exxon area.

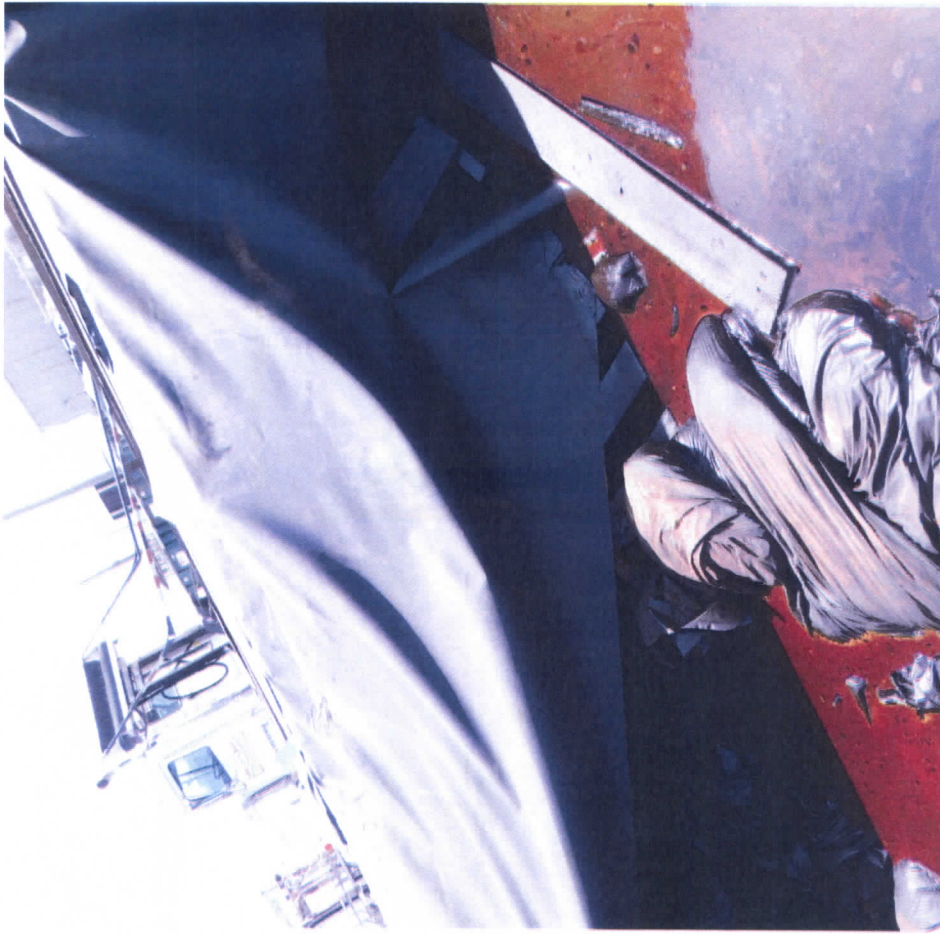
1. As shown in Att. 1.a photos 738 to 744 (June 12, 2019) taken in the Tank 519 Waste Management Area, the Facility failed to properly manage and control waste materials in and around dumpsters as required by Stormwater Part F.1.f.ii of the SW Permit. Additionally, Part E.1 requires proper operation and maintenance of the facility. Part VI of the Facility's Stormwater Pollution Prevention Plan ("SPPP") requires roll-offs to be covered except when being loaded or unloaded and requires weekly inspections. The inspection identified that:

- a. Dumpster covers were torn and not being maintained.
 - b. Dumpsters contained oil wastewater/stormwater and were leaking on the ground.
 - c. Oily material/hay was seen outside of the dumpsters.

The Facility representative indicated that this area was to be inspected once per week, however judging by the condition of the covers and accumulation of oil water inside and around the dumpsters it does not appear that weekly inspections were taking place. The Facility representative said that they would report this to NJDEP by filing an incident report of discharge to ground. This portion of the Facility was not being operated and maintained in accordance with Part E and F of the SW Permit.

DSCN6738 – oily wastewater/stormwater in dumpster with cover partially off, dumpsters were leaking – Tank 519 Waste Mgmt. Area

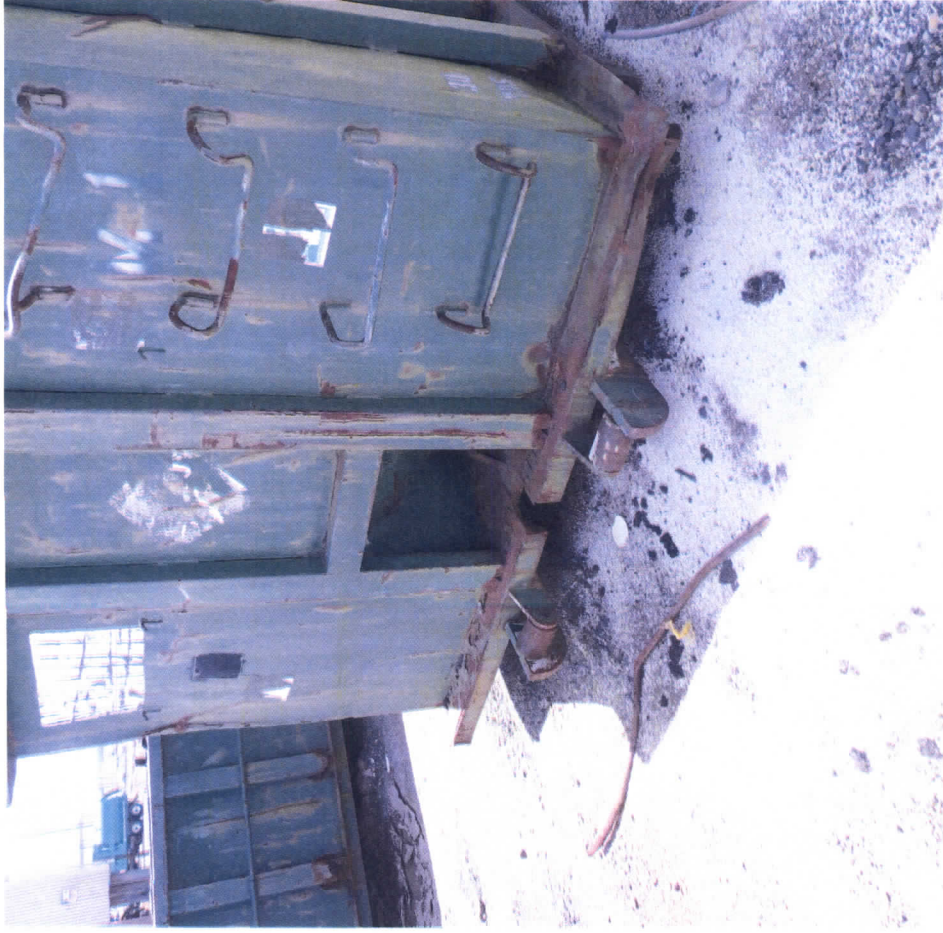
DSCN6744 – pellets outside of dumpster on ground in tank 519 waste area

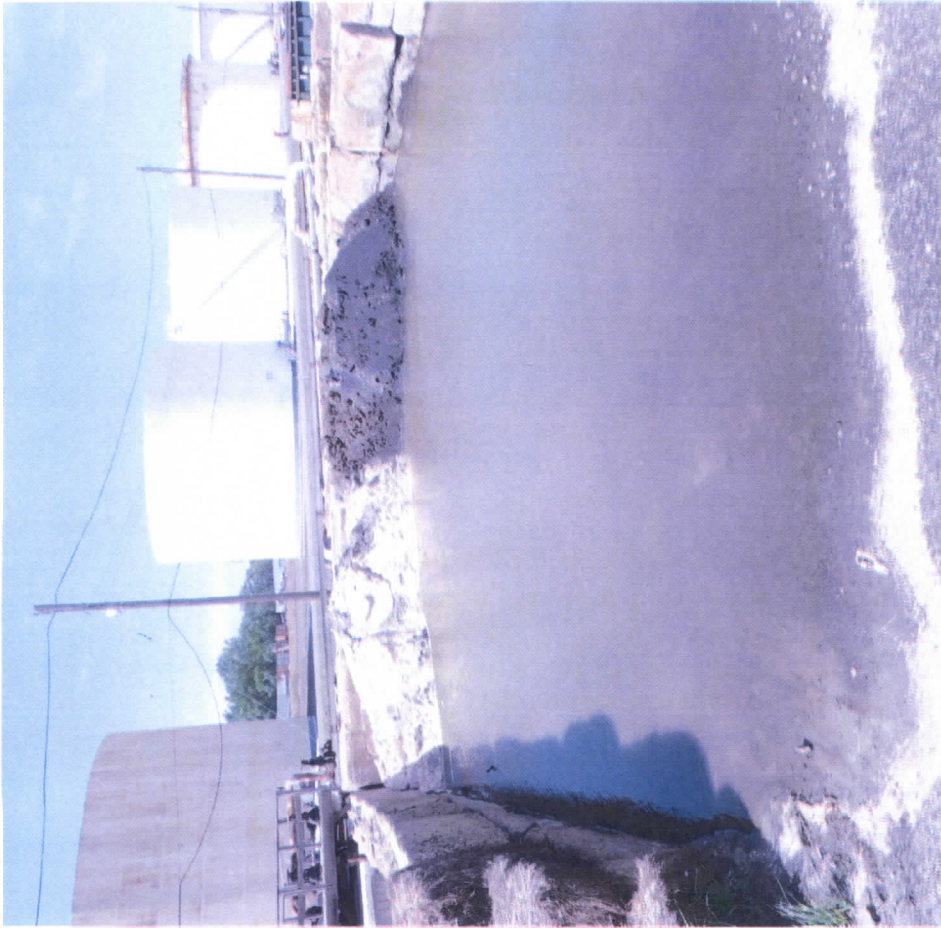
DSCN6746 – Materials in bermed area

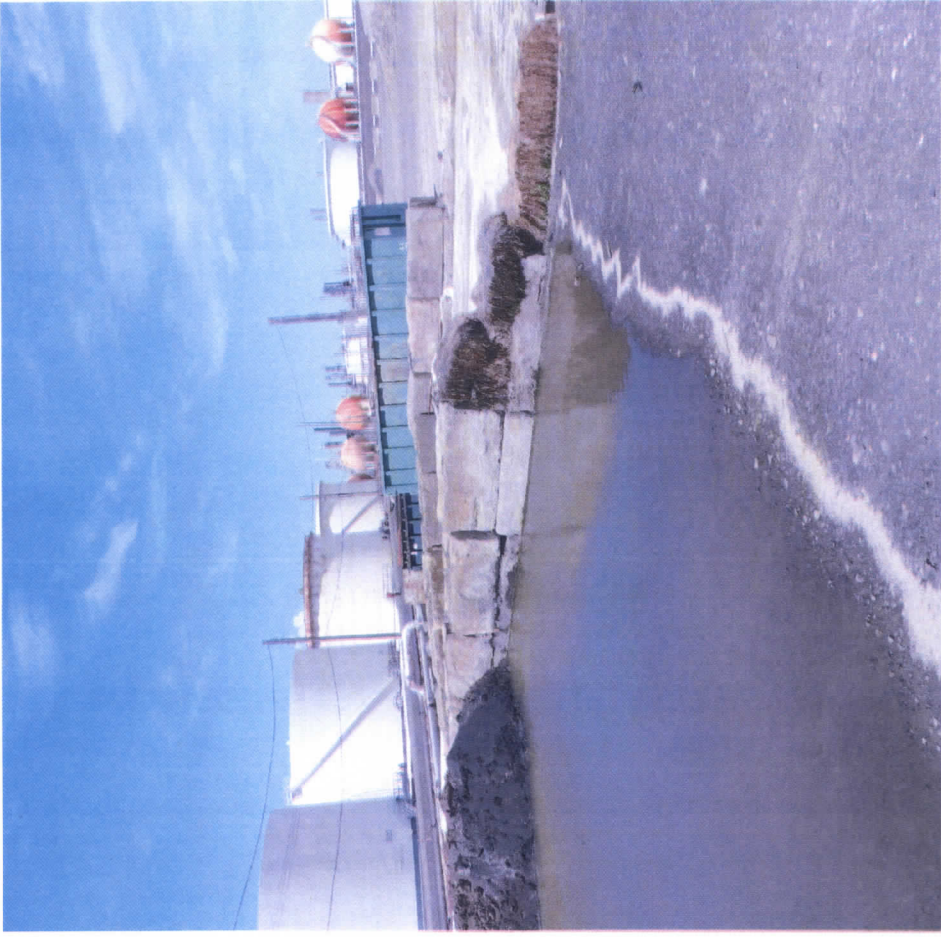
DSCN6747 – materials in bermed area

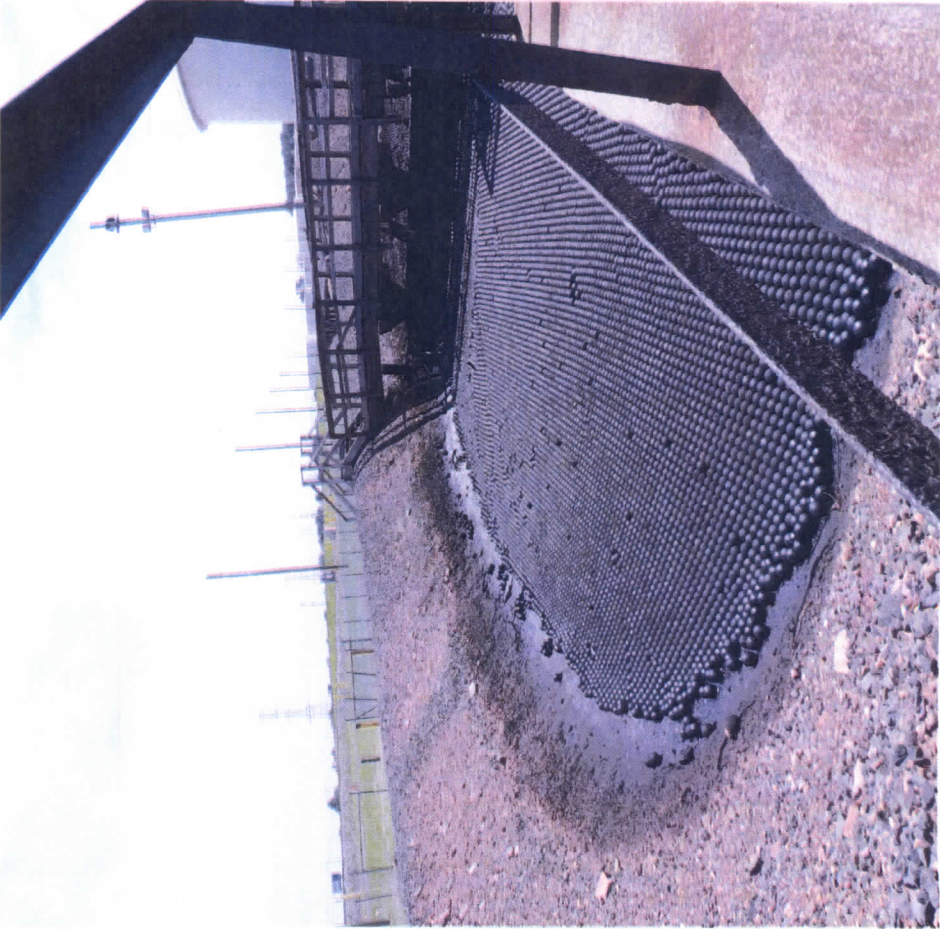
5	010	748-753	<p>As shown in photos 748 to 752 (taken on June 12, 2019) (Att. 1a), the Tremley Tank Field separator had a layer floating oil in the separator, the banks were oil stained, and there was a sheen and an oily sorbent pig in the outlet chamber prior to the outlet valve. Outfall 010 discharges to Moses Creek, but has no monitoring requirements in the SW Permit. The Facility representative said that this separator drains a large tank field, but there is no process sewer in the vicinity to route flows to the WWTP. During the June 12, 2019 inspection, as shown in photo 753 the outlet of the 010 channel prior to entering Moses Creek did not have a sheen.</p> <p>Daily visual inspections of the Tremley separator are conducted and records for January through June 2019 were provided to EPA following the inspection. However, the visual inspections of the separator on June from 11, 12, and 13 (Att. 5) did not identify any accumulated oil in the outlet box. But EPA and NJDEP did identify a sheen and oily sorbent pig in the outlet box on June 12, 2019.</p> <p>Proper operation and maintenance of the separator (a Best Management Practice) is required under Parts IV.E.F. and G of the SW Permit in accordance with the Permit. And Operators should be trained to identify oil in the outlet box as well as a layer of oil in the separator itself that necessitates cleaning of the Separator.</p> <p>The outfall from this separator does not currently have chemical monitoring requirements in the permit, but NJDEP has requested that monitoring of the discharges from this outfall be conducted for parameters and frequency consistent with other outfalls in the stormwater permit.</p>	PNC

DSCN6748 - Tremley Tank Farm Outfall 010 separator, layer of floating oil seen in the separator and staining the banks

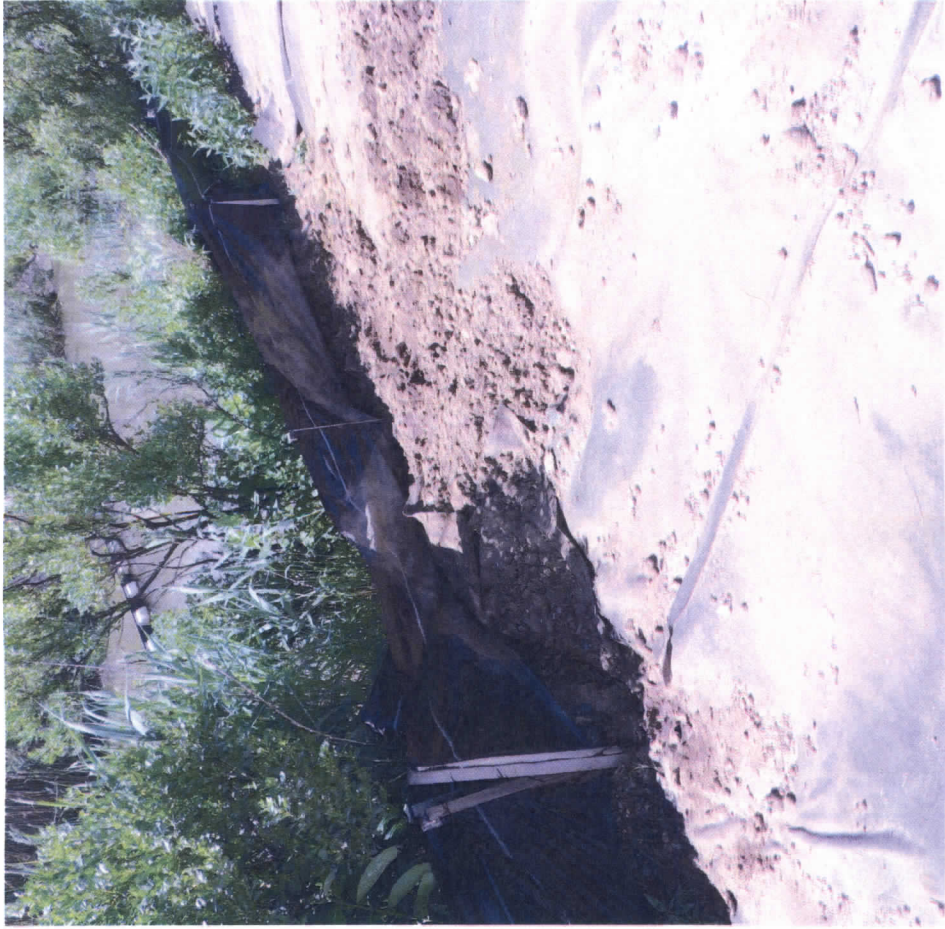
DSCN6754 – Exxon RCRA Area Land Farm unstabilized soils

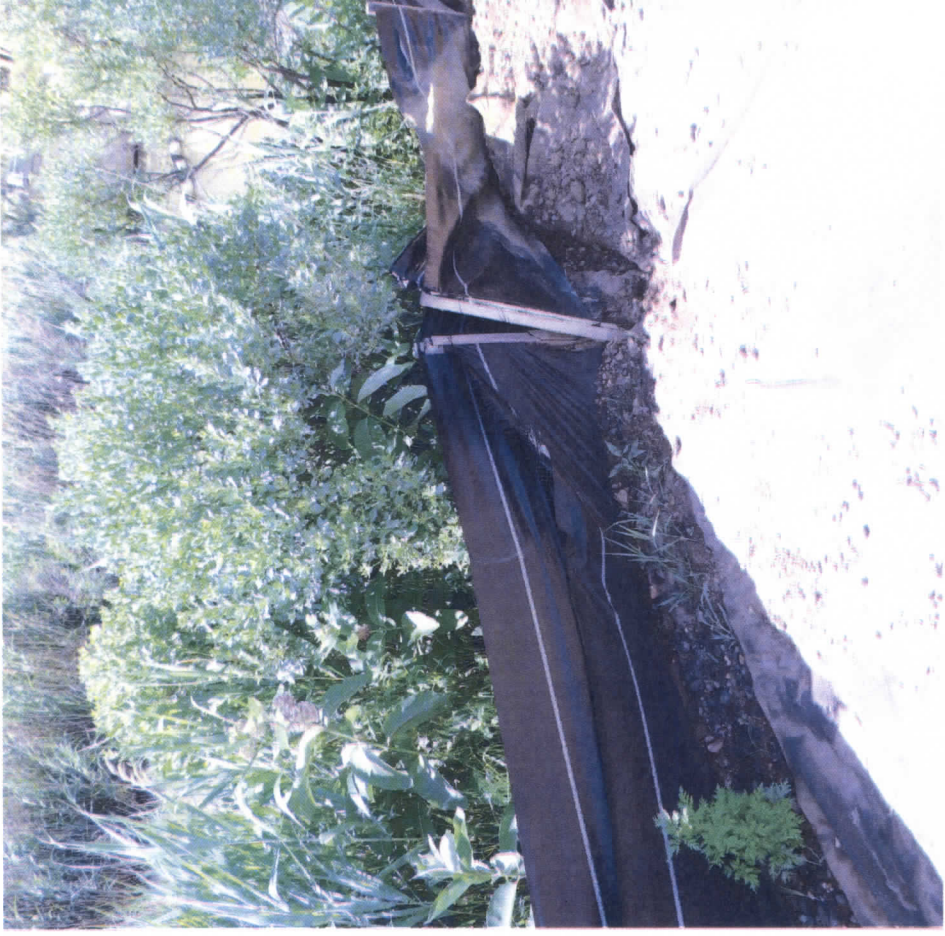
DSCN6755 - Exxon RCRA Land Farm Area unstabilized soils

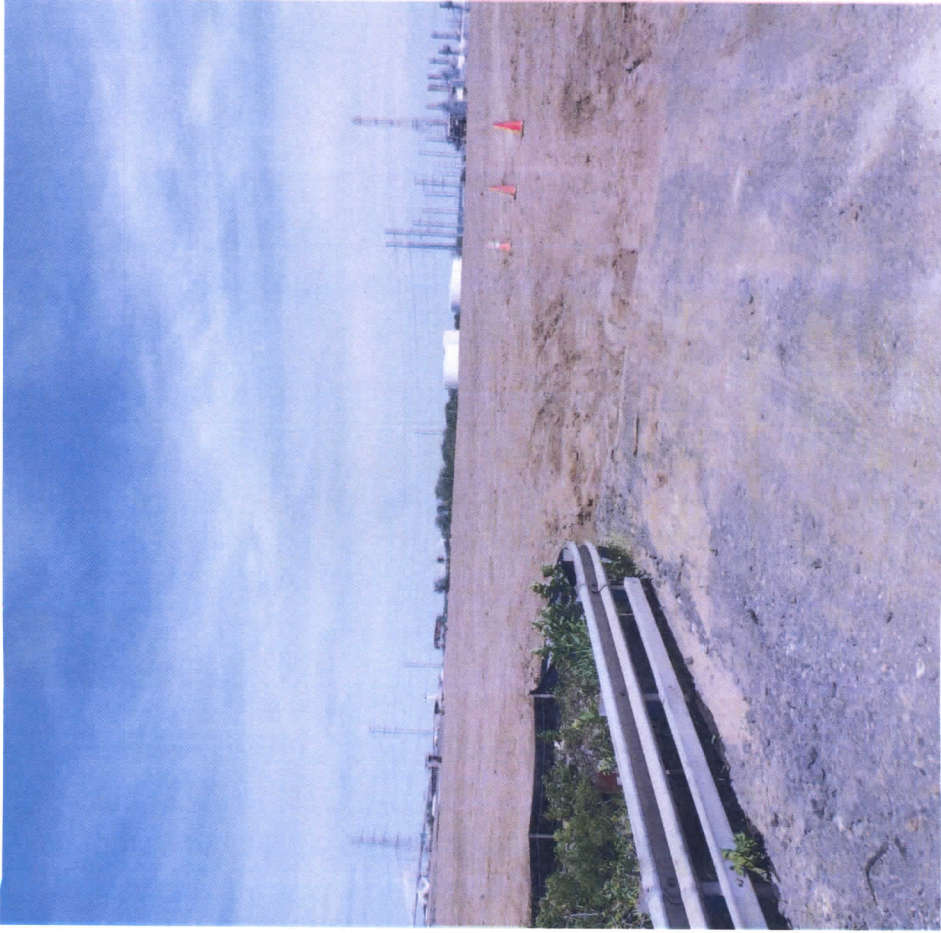
DSCN6756 - Exxon RCRA Land Farm Area - unstabilized soils, silt fencing in place.

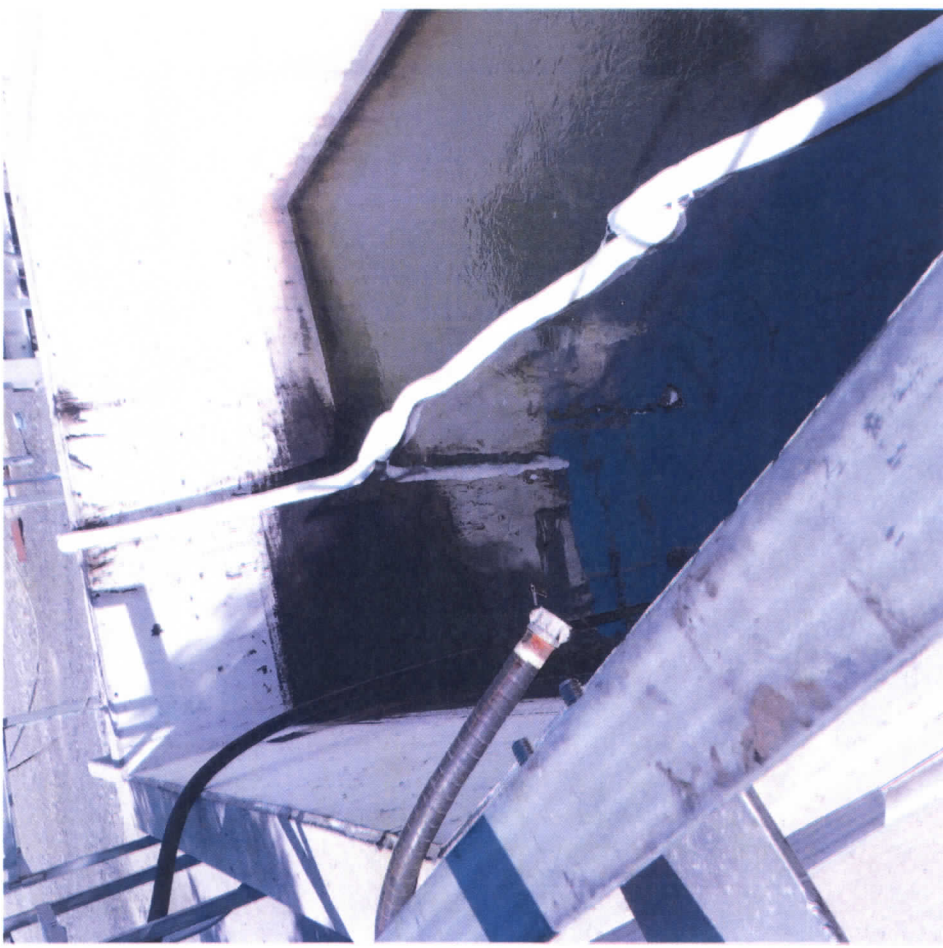
DSCN6759 – oil was seen in the first part of the 003 separator.

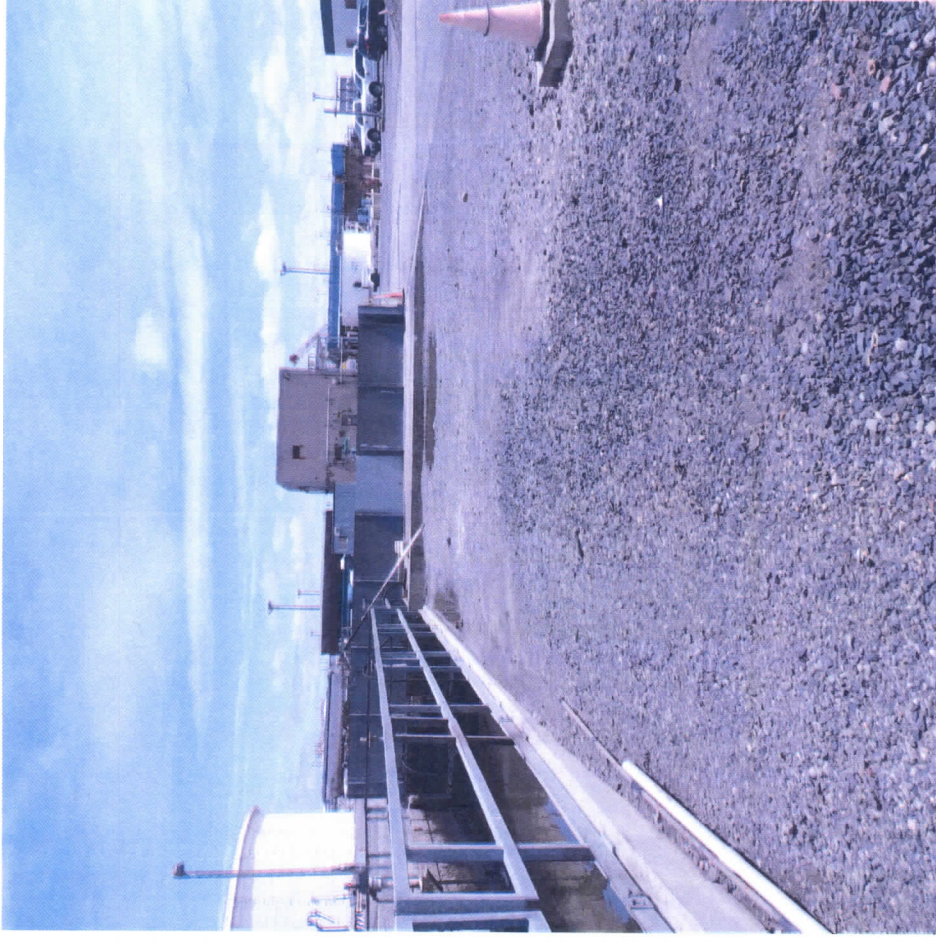
DSCN6769 – influent channel bypass is blocked off. Some flood control walls seen in place, additional portable dikes can be put in place.
